<div> DAVIE COUNTY, NC FIRE MARSHAL'S OFFICE STANDARD OPERATING GUIDELINES </div>	REVISION DATE 12/13/2018
SUB DOCUMENT LIGHTWEIGHT CONSTRUCTION	ADMIN PAGE 1 OF 22
DCFM #	500-008A

1. INTRODUCTION

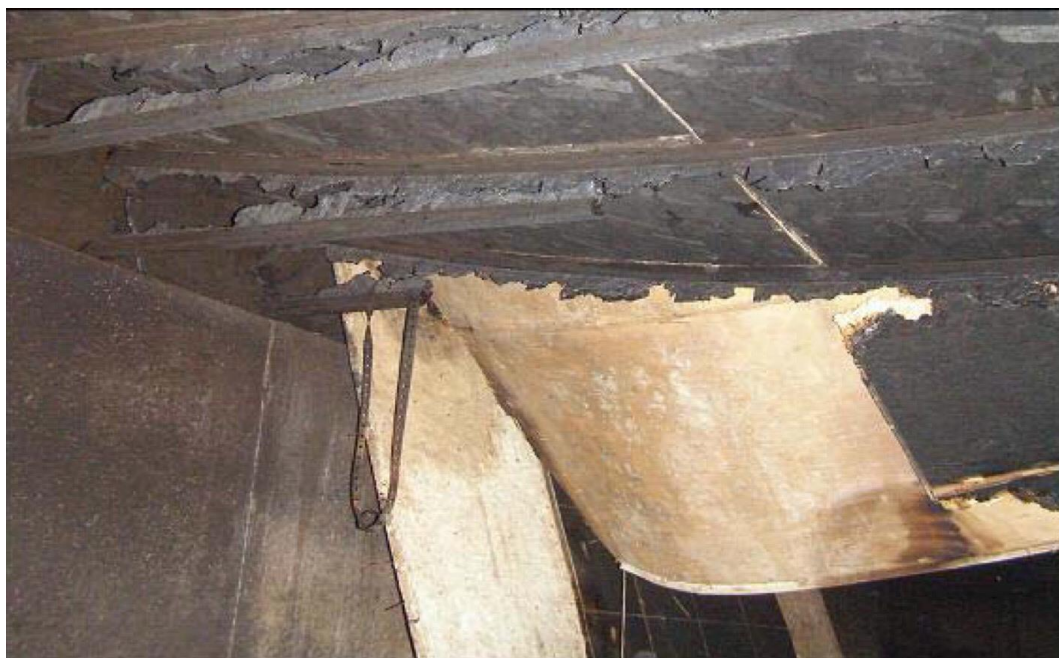
Figure 1

- 1.5. In any building construction, the critical area subject to failure as a result of fire is the point of connection.
- 1.6. For fires in “**traditional**” private dwellings built of ordinary/wood frame construction, early collapse is not a primary consideration. At these types of buildings, depending on the duration and intensity of fire, the size of the structural components, and the type of construction involved, the amount of time before collapse occurs is generally estimated to be an hour. However, when there is no ceiling to provide protection, therefore exposing structural components, failure can occur within 20 minutes.
- 1.7. In private dwellings constructed with **lightweight materials**, when fire extends from the building's contents to its structural components, collapse may occur within 5 to 10 minutes. (Figure 1)

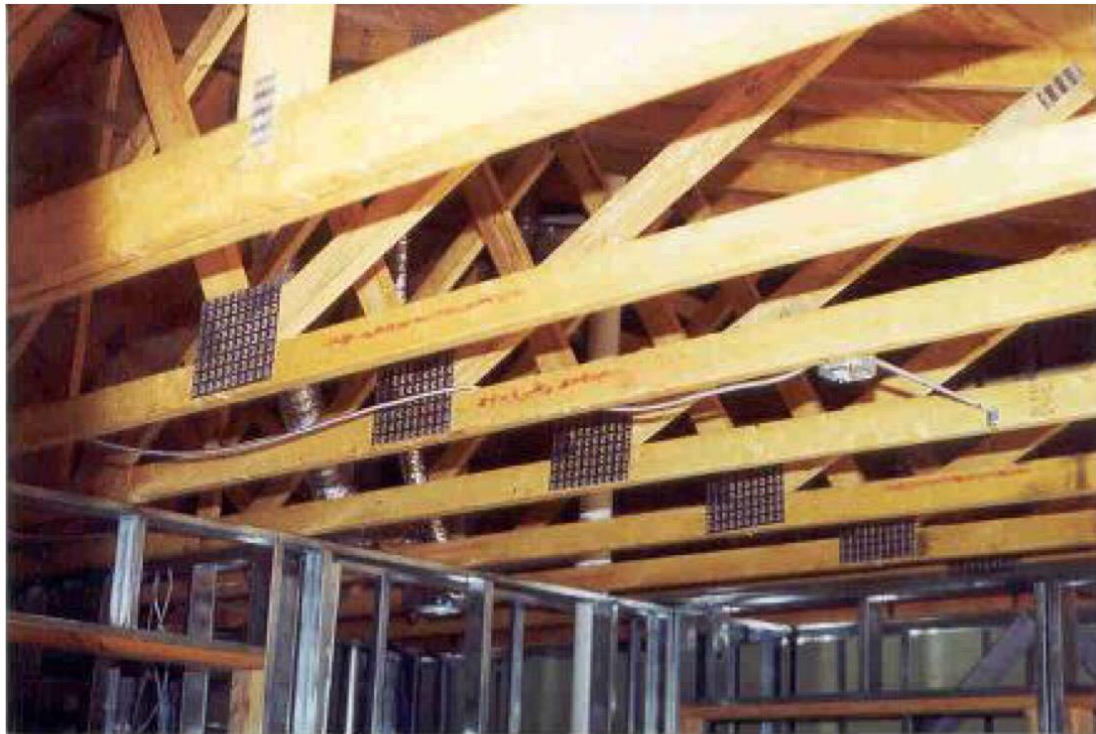
Figure 2

- 2.2.5. Roofs – Lightweight wood truss roofs may be flat or peaked. A large, open cockloft/attic is commonly found in either design.
- 2.2.6. The most common type of peaked roof found in lightweight construction is the open-web lightweight wood truss. In an ordinary peaked roof structure with dimensional lumber, the collapse of the roof rafters and roof deck may be supported by the ceiling beams below, thereby protecting firefighters operating on that floor. When a lightweight wood truss peaked roof is exposed to sufficient fire, the rafters (top chord of the truss), the roof decking, and ceiling joists (bottom chord of the truss) can be expected to collapse as one complete unit into the structure, exposing firefighters to falling and burning debris. (Figure 2)

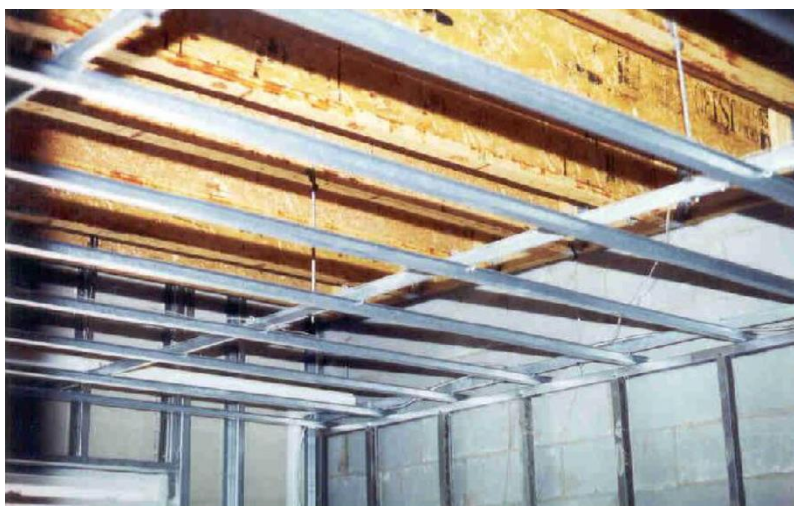
Figure 3

2.3.2. In some larger private dwellings, the drywall ceiling may be installed several inches below the lightweight supporting members to provide for the running of utilities. This type of installation is more prevalent in cellars with wood I-beam and metal C-joist construction than the open web truss due to the lack of horizontal openings to run utilities. The result is a large open area between the ceiling and the joists, creating the potential for rapid fire spread and extension. (Figure 3)

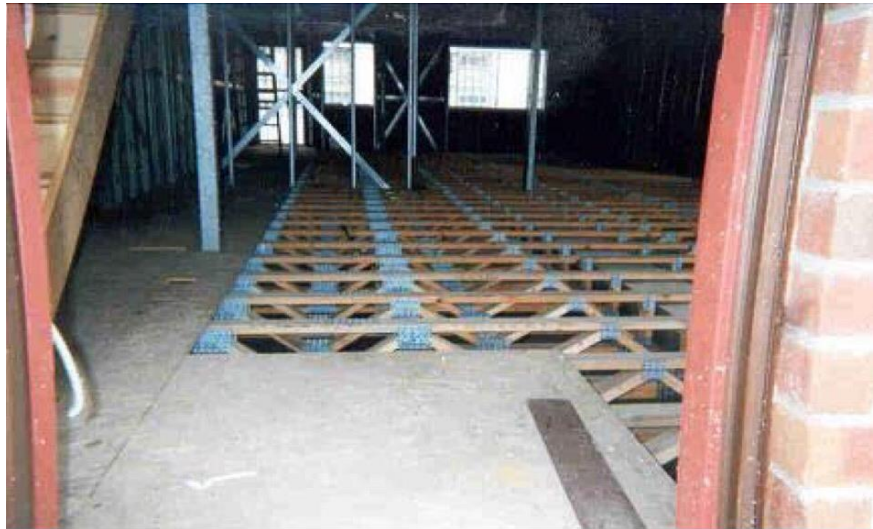
Figure 4

This type of support system is made up of 2x3" or 2x4" wooden web and chord members connected with sheet metal gusset plates (also referred to as gang nails). Since these connections only penetrate 1/4" - 1/2" into the wooden truss member, the gang nails are the weakest point of the support system. When exposed to fire and/or high heat, failure at the point of connection should be expected before failure of the structural wood components.

When lightweight wood trusses are exposed to fire, high heat, or prolonged exposure to water, the gang nails may loosen and fail, causing the entire span of that particular truss section to fail. The surface-to-mass ratio of the wood trusses provides an abundant fuel source, and the air supply in the concealed truss void allows for rapid horizontal extension. Due to the open-web characteristic of the truss system, fire which has entered a ceiling (trussloft) or roof space (cockloft/attic) may likely affect all truss supports on that level, creating the potential for a large-scale collapse of the area supported by the affected trusses. (Figures 4 and 5)

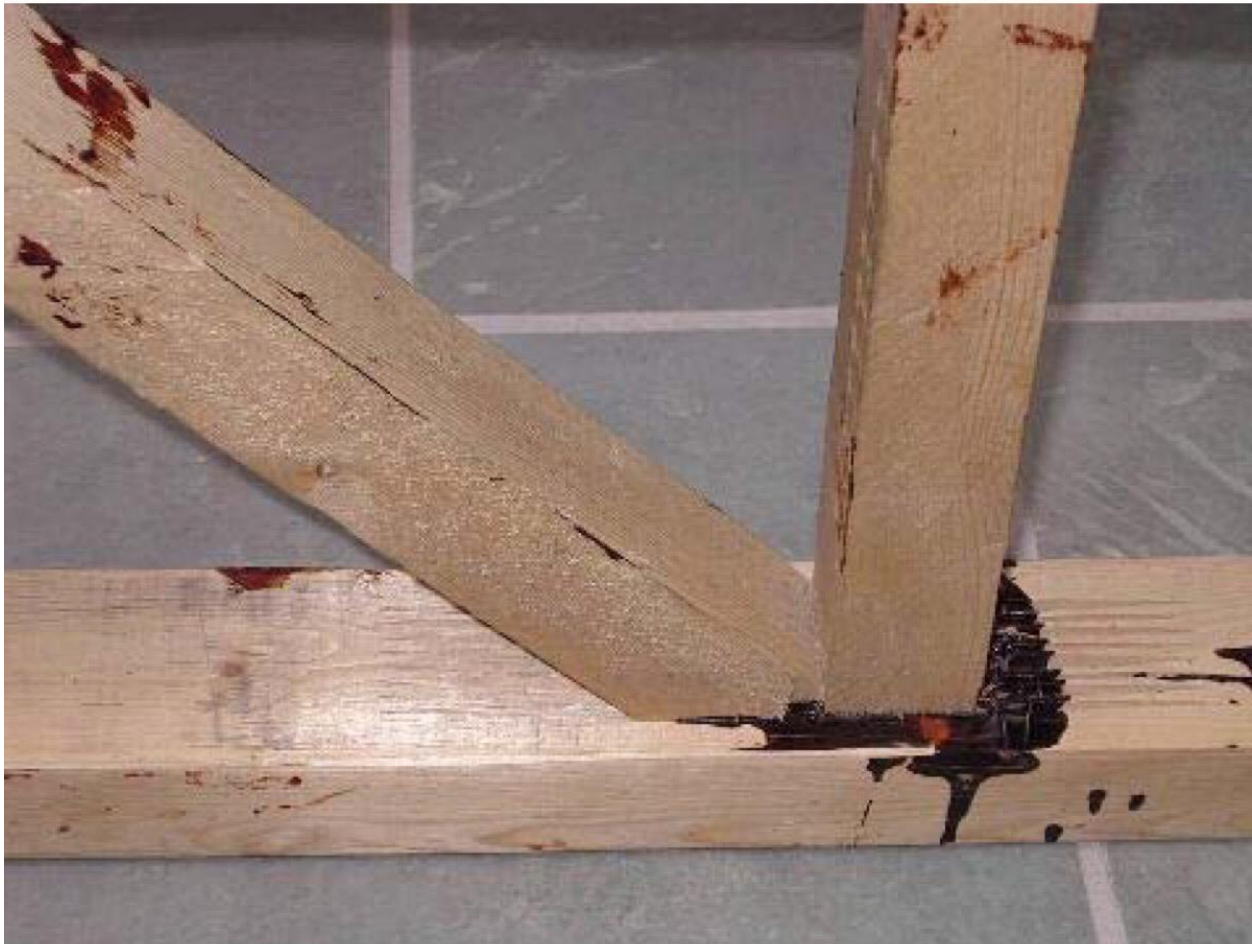
Figure 6

Another type of open-web wood joist uses finger joints and glue to connect the web and the chords.

The finger joints are approximately $\frac{3}{4}$ " deep; and, similar to parallel cord wood truss without the metal gusset plate, these trusses can be expected to fail rapidly when exposed to fire and/or high heat. (Figure 6)

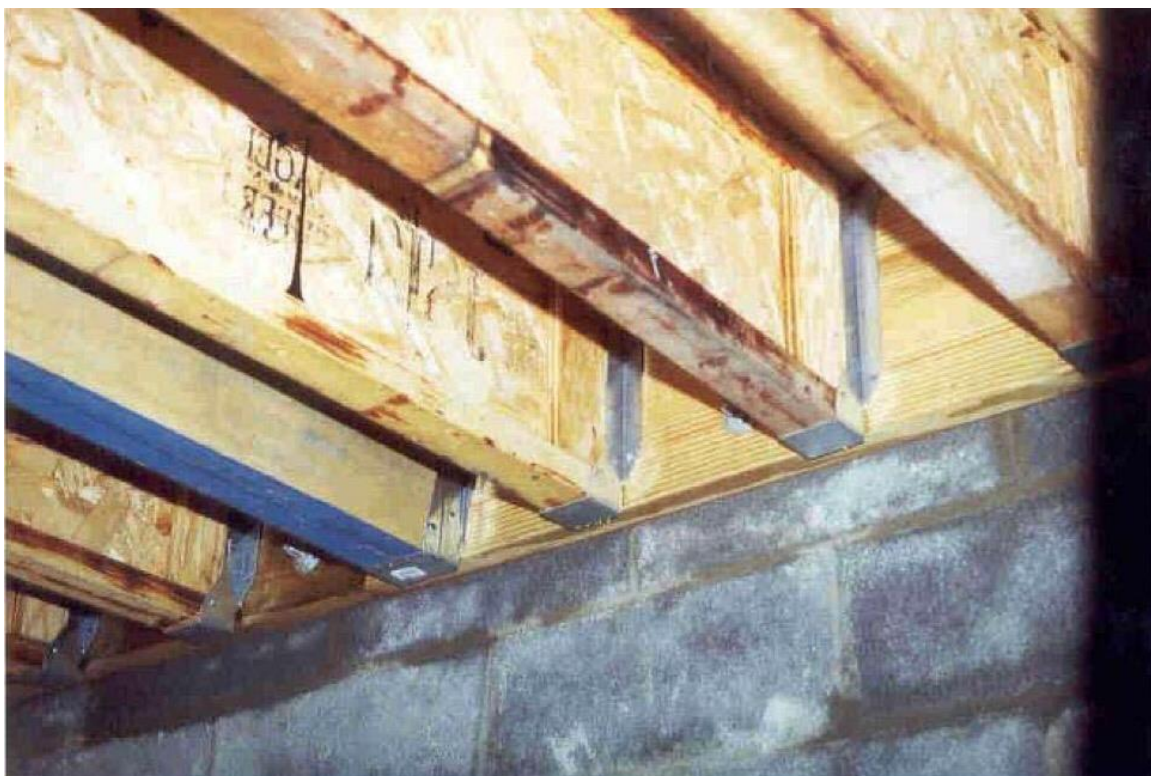
Figure 7

This type of support system is primarily comprised of 1/2" oriented strand board (OSB) or 3/8"- 1/2" plywood web members, and 2x3" or 2x4" wood flanges. The web is fitted and glued into a routed slot in the top and bottom flanges. In some cases, they may span lengths of over 60 feet. The strength of the beam is a function of the mass of the flange and the depth of the web. These beams are usually connected to load bearing walls with sheet metal joist hangers. These I-beams are pre-engineered, and may come with openings in the web to accommodate utilities. In other instances, builders will bore holes in the web for plumbing, electrical lines, and HVAC ductwork, thus compromising its strength. A fire-retardant material sprayed on the beam will tend to dry out the wood over time, making it brittle and further reducing its strength. Once the ignition temperature has been reached during a fire, a laminated wood I-beam will burn rapidly. The sheet metal brackets holding the beams in place may also fail when exposed to fire or high heat. (Figure 7)

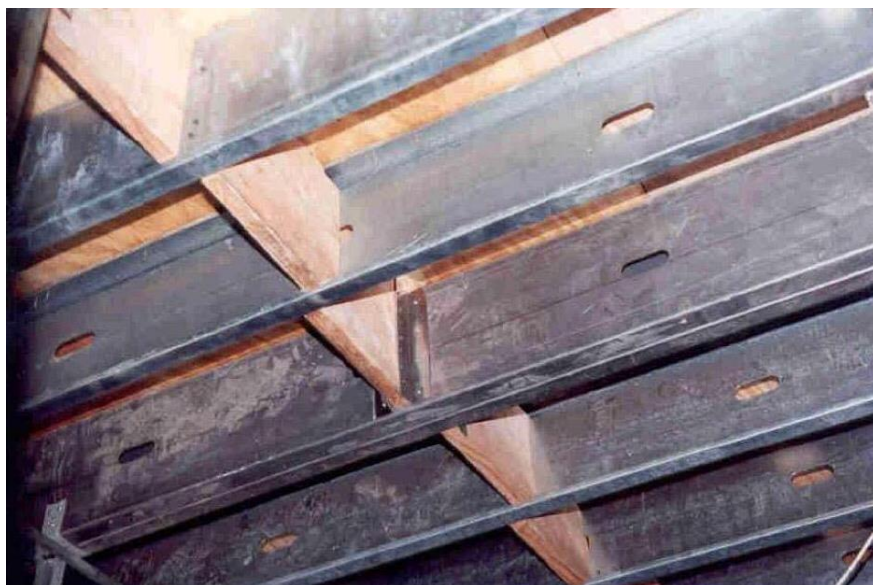
Figure 8

Metal C-Joists may come with pre-drilled holes for plumbing and electrical lines. (Figure 8) A newer type of C-Joist, with design characteristics similar to lightweight parallel chord wood truss, has larger openings that allows for the easier running of utilities, and the potential for fire and heat spread is significantly greater. (Figure 9) When exposed to fire and/or high heat, these lightweight steel joists will lose strength and fail rapidly.

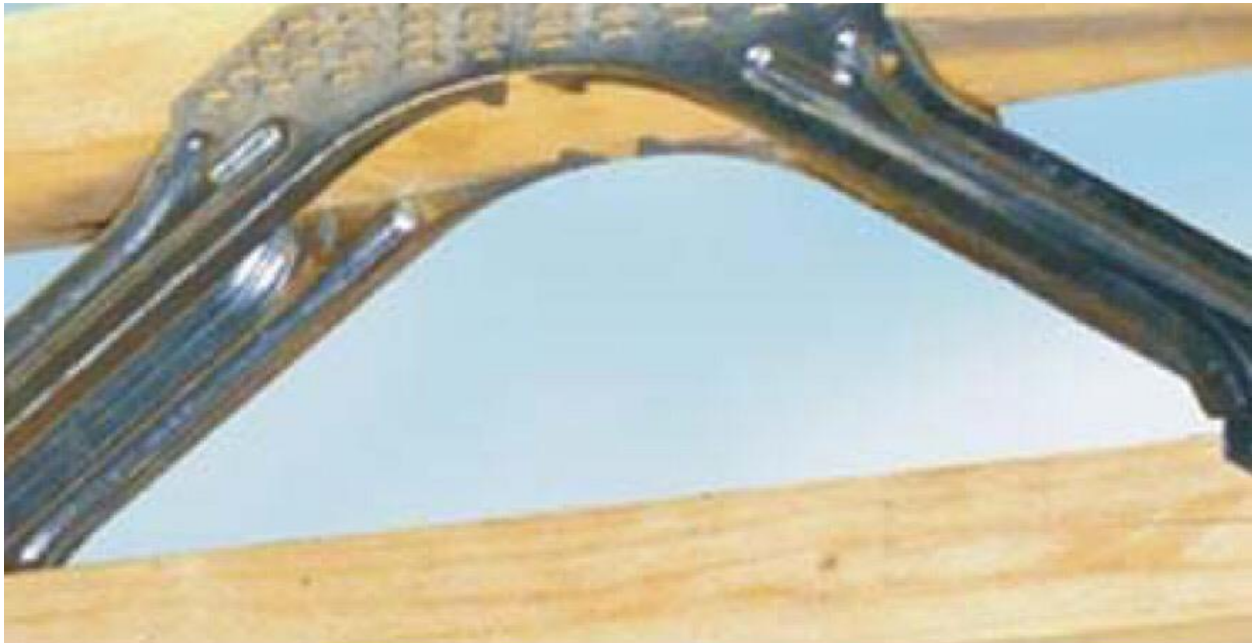
Figure 10

This type of truss system is similar in design to a lightweight parallel chord wood truss, but comprised of two types of materials: wood and steel. A formed sheet metal web is attached to 2x3" or 2x4" wood chords with nails or sheet metal gang nails. It is commercially known as a "Space Joist".

- Under fire conditions, the composite truss will react the same as other lightweight (wood or metal) trusses, they will lose strength and fail rapidly (Figure 10)
